PASSAIC RIVER BASIN
TRIBUTARY OF WHIPPANY RIVER
MORRIS COUNTY
NEW JERSEY

N.J. NO NAME
DAM NO. 53
NJ 00809

PHASE 1 INSPECTION REPORT
NATIONAL DAM SAFETY PROGRAM
DACW61-79-C-0011

REPT. NO: DAEN/NAP-53842/NJ00809-81/03

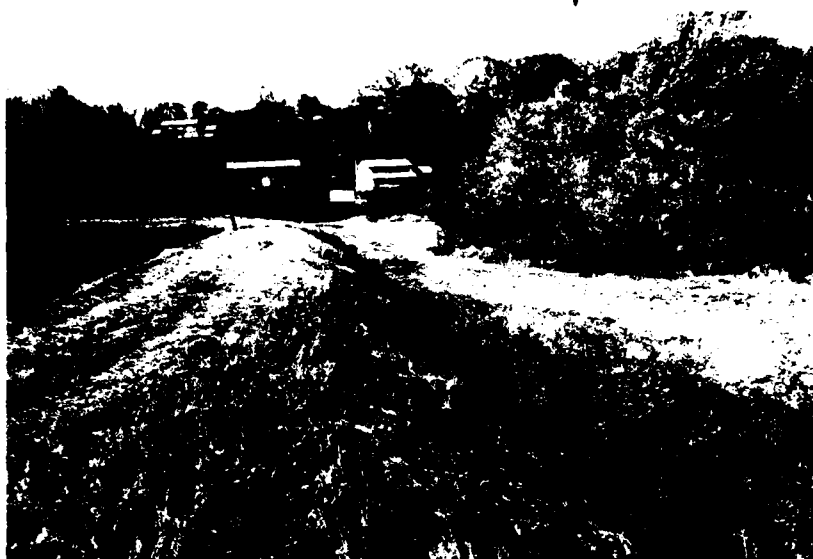
Upper dam embankment and berm
looking west.

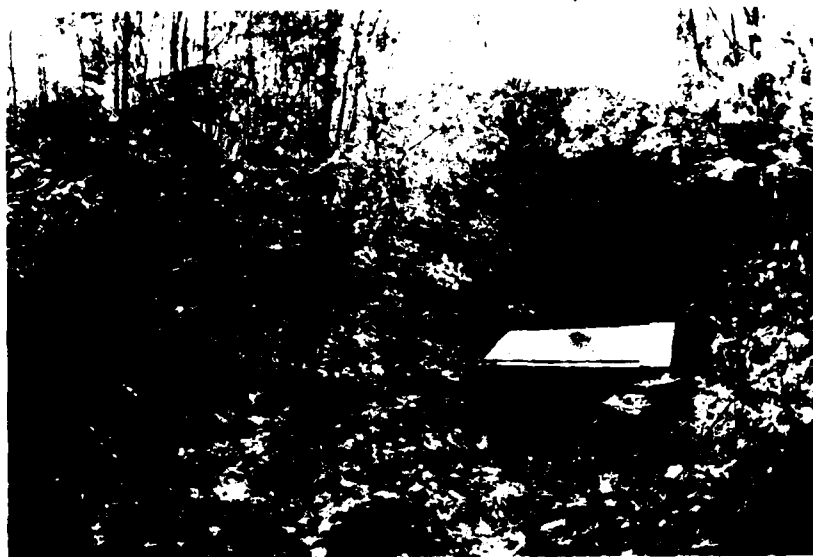
Debris covered pit for effluent
pipe control. Note entrance shaft
for emergency low level outlet
control located in upper left
corner of photograph.

(2) Determine the operating condition of the emergency low level outlet, repair if necessary, and provide safe access to the control.

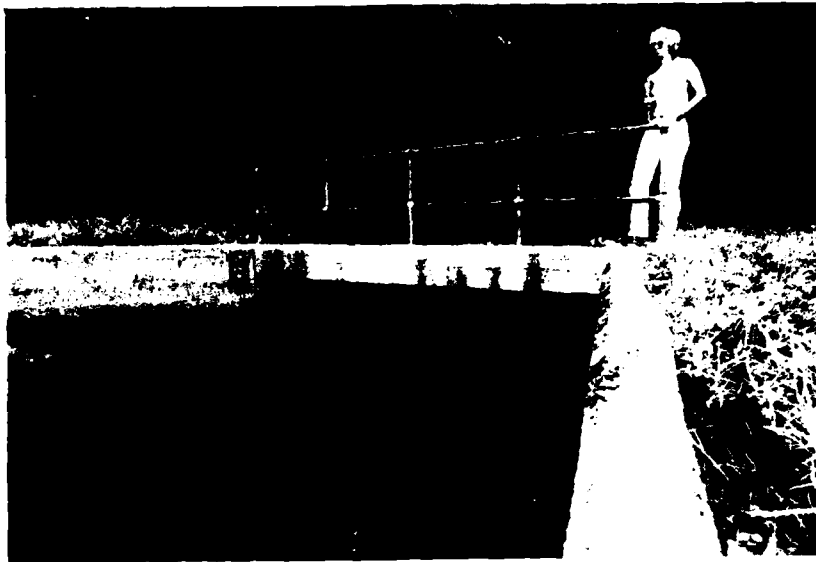
Concrete walkway over spillway,
upstream side.

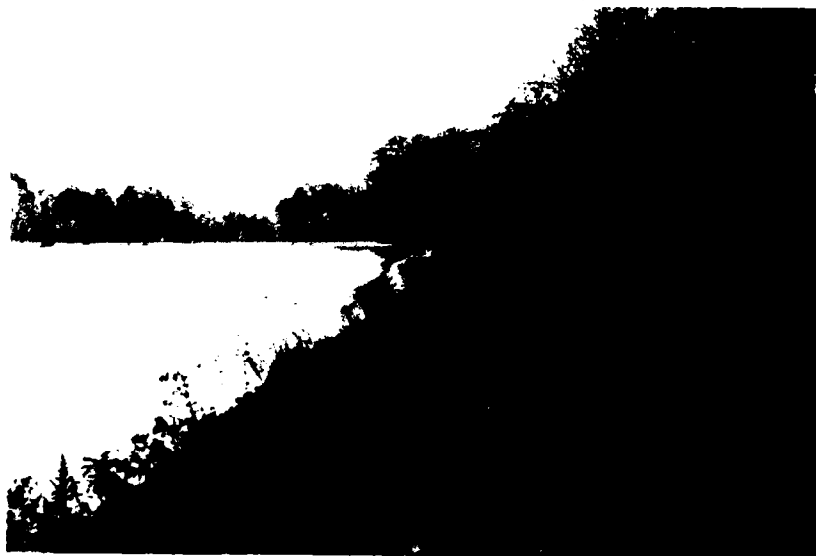
The earth dike along the east side of the reservoir is vegetated with brush and grass and appears in poor condition. The crest surface is uneven and significant erosion has occurred in the area near the junction of the dike and the spillway. An animal burrow was found on the crest of the dike. The stream channel which flows along the east toe of the dike is about 3 to 4 ft below the crest. There is no toe or slope protection along the east side of the dike and significant erosion has occurred. The west slope of the dike is riprapped to near the normal pool level.

Dike along east side of reservoir
looking north. Brook flows along
east side of dike to spillway
discharge flume.

(3) Repair and provide proper protection against further erosion along the east side of the secondary dike.

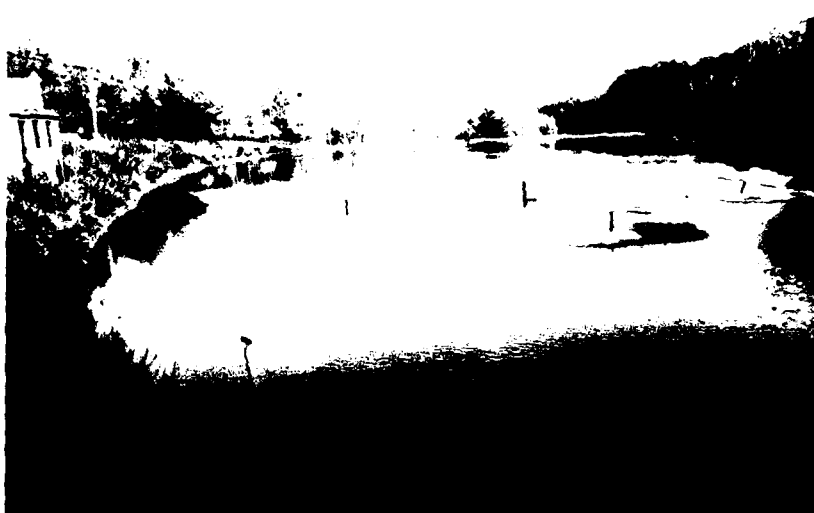
Reservoir looking downstream.

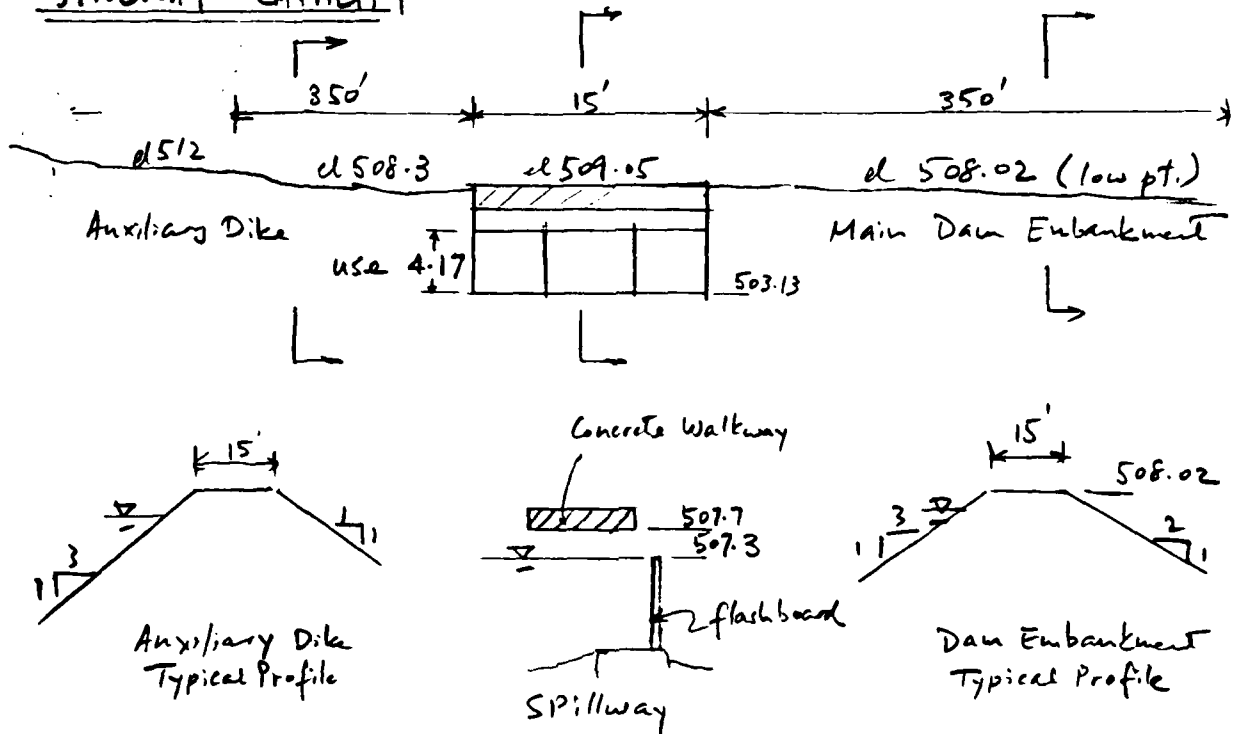
SPILLWAY CAPACITY

At spillway section, when pool surface is below bottom of concrete walkway ($el\ 507.7$), discharge over flashboards is weir flow. Take spillway section as a broad-crested weir. Choose C from Table 5-3 of 'Handbook of Hydraulics' by King & Brater (5th Ed.) Take $C = 3.32$

When pool surface is above $el\ 509.05$, discharge includes orifice flow between bottom of walkway and top of flashboard and weir flow over walkway and dam. Assume average $C = 0.62$ for orifice flow and use values of C from Table 5-3 of King & Brater

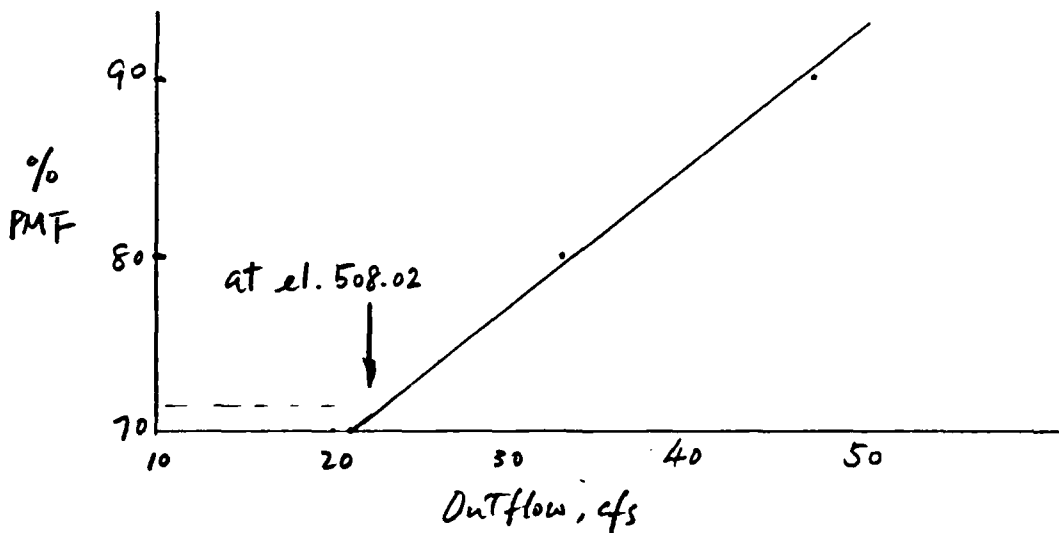
OVERTOPPING POTENTIAL

3. Dam overtops at el 508.02 with $Q = 22$ cfs
 \therefore dam can pass approximately 71% of the PMF
